INVESTIGATION OF EXPLOSION SAFETY OF DC POLYMER SURGE ARRESTERS 3.3 KV FOR TRACTION NETWORK OF RAILWAY TRANSPORT

The goal of the work is the determination of the explosion safety of SAP-3.3 kV samples with a polymer case on the equipment of an operating DC traction substation under conditions as close as possible to operation.

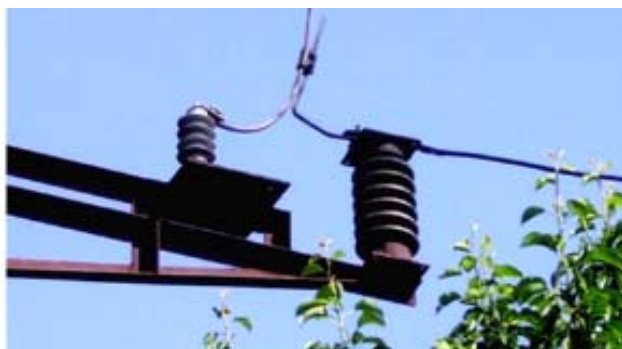
Fig. 3. Sample of SAP prepared for testing

The sample of the surge arrester was mounted on one of the metal poles at height of 5.5 m located on the territory of the substation and connected to the traction substation buses of 3.3 kV via disconnecters A5, B5, ΦЛ5 and high-speed circuit breaker BAB-206 (Fig. 3).

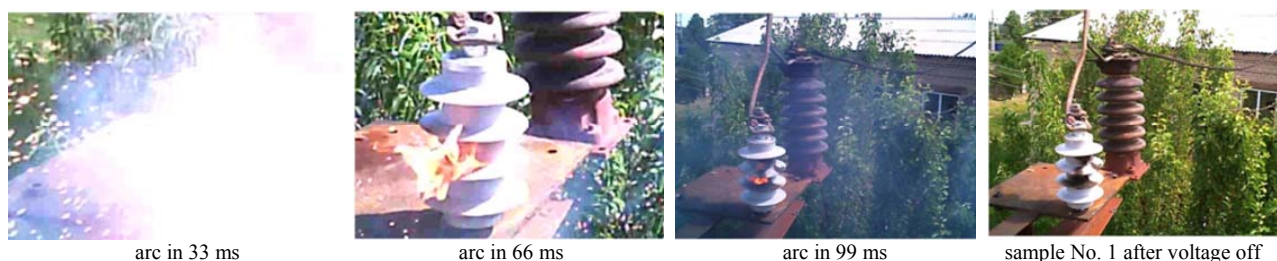
Fig. 5. Freeze frames of the arc exit from the SAP case after BAБ-206 switching on

2. In two other samples No. 1 and No. 3, made similarly by a continuous winding with a glass banding tape, a local gap of the frame and the silicone coating was observed with the arc going out. Scattering of dangerous fragments was absent. In about 100 ms, the electric arc reached the surface was completely extinguished, this can be seen on the freeze frames received every 33 ms (Fig. 5). For the remaining 5 samples, the observed arc burning pattern was similar, as for samples No. 1 and No. 3 (Fig. 5).
